**United States Environmental Protection Agency Region III
Corrective Action Program**

ENVIRONMENTAL INDICATOR INSPECTION REPORT

**Former Union Switch & Signal Division
1789 Braddock Avenue
Pittsburgh, Pennsylvania 15218
EPA ID # PAD 000001115**

January 2009

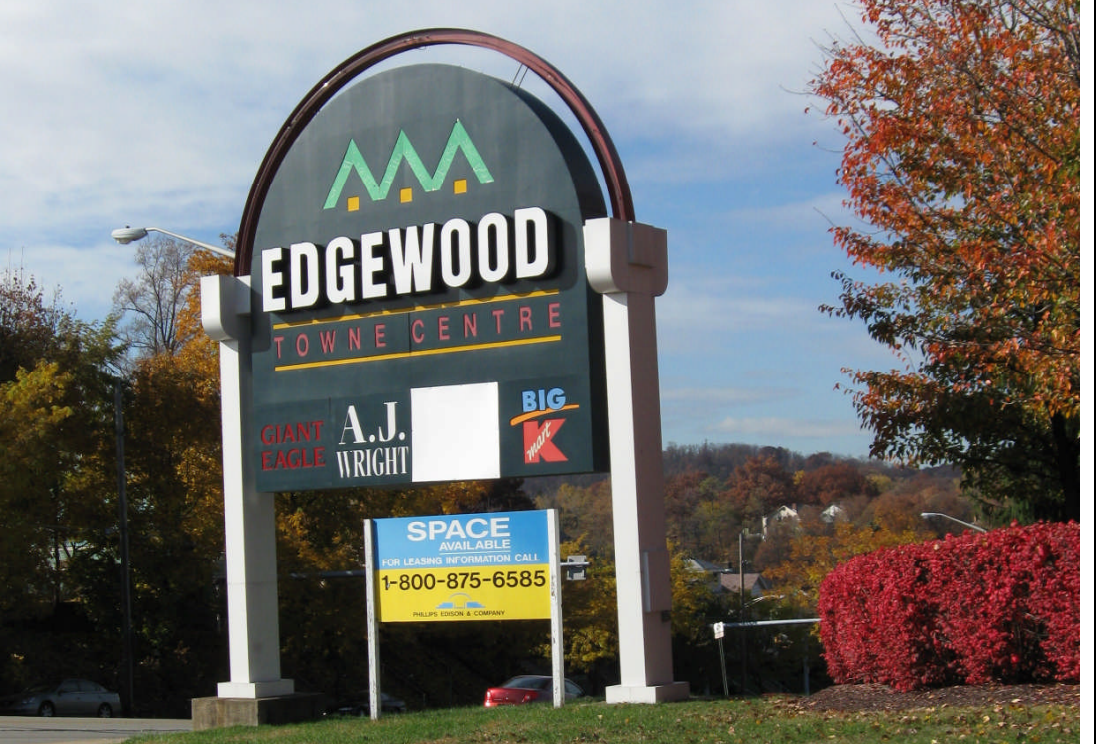
Client Name: Pennsylvania Department of Environmental Protection		Site Location: 1789 Braddock Avenue, Pittsburgh, PA 15218	Project No. 20497896
Photo No. 1	Date: 11/6/08

Direction Photo Taken: North			
Description: Sign located at the entrance to the Facility.

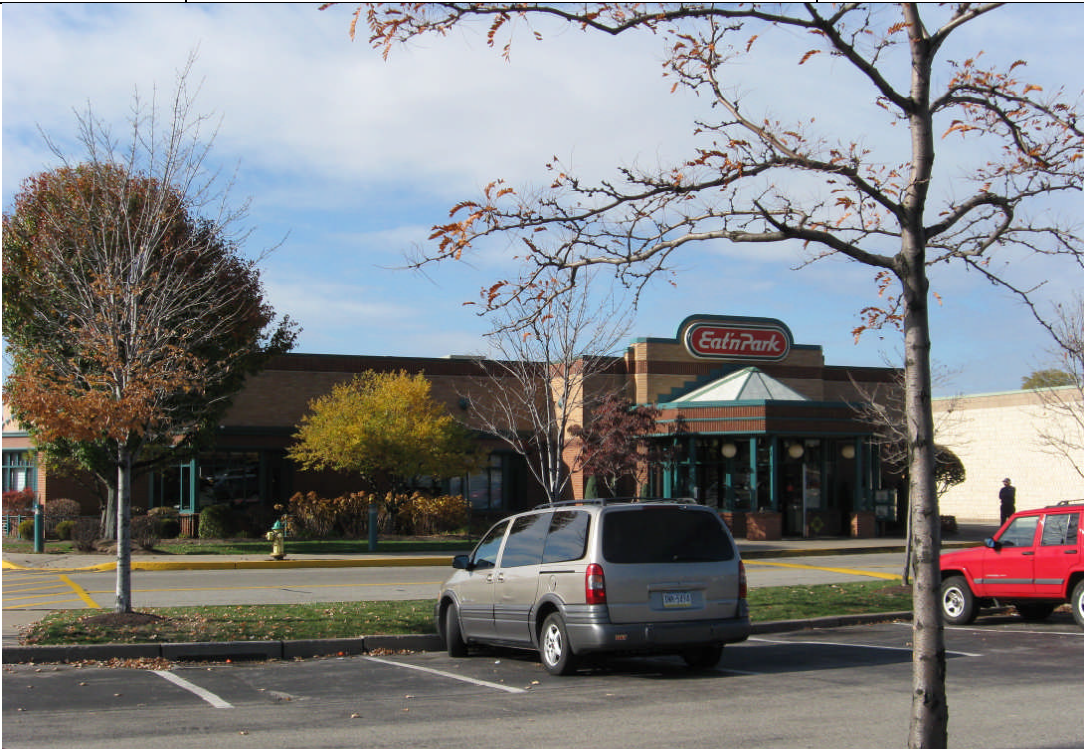
Client Name: Pennsylvania Department of Environmental Protection		Site Location: 1789 Braddock Avenue, Pittsburgh, PA 15218	Project No. 20497896
Photo No. 5	Date: 11/6/08

Direction Photo Taken: North			
Description: Shops located in the Edgewood Towne Center.

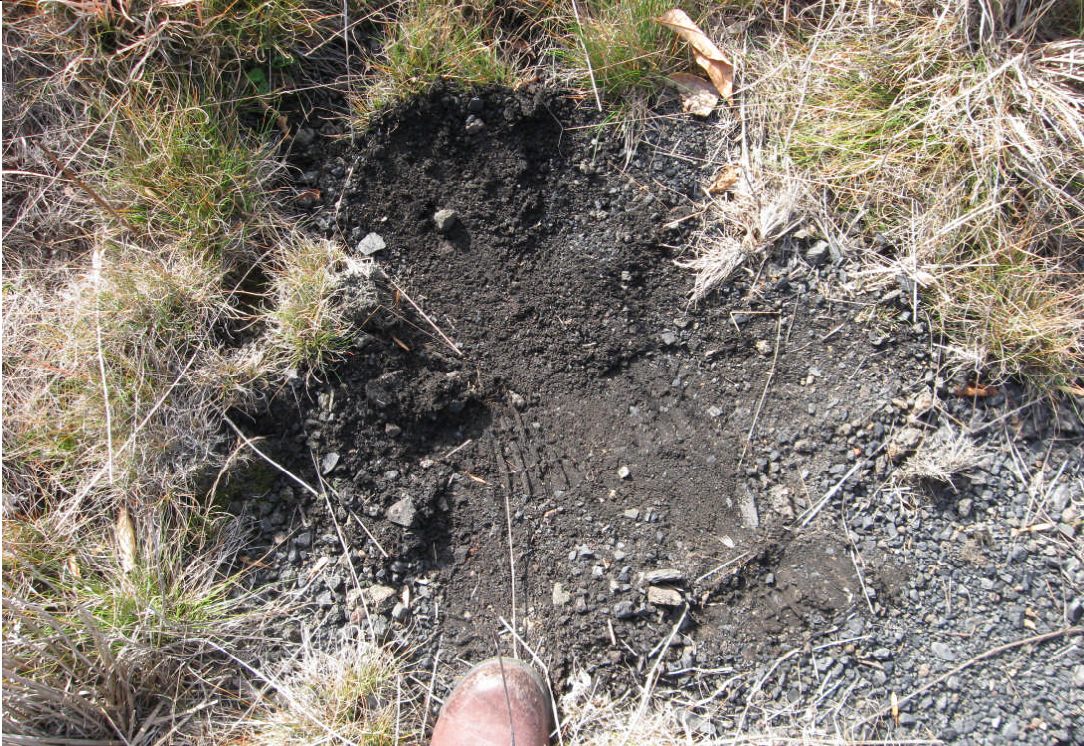
Client Name: Pennsylvania Department of Environmental Protection		Site Location: 1789 Braddock Avenue, Pittsburgh, PA 15218	Project No. 20497896
Photo No. 9	Date: 11/6/08

PADEP and URS walked around the upper parking lot area and in the undeveloped land west of the upper parking lot. The following two different soil types were observed in the undeveloped land west of the parking lot: 1) black to dark grey fill material containing gravel and asphalt fragments (**Appendix B, Photograph 9**) and 2) light brown sand and silt, poorly sorted with some gravel (**Appendix B, Photograph 10**). A dry drainage ditch exists below the upper parking lot along with two vertical, unused light poles in the brush north of the drainage ditch indicating a possible former access road. The SWMUs 1 through 5 identified in the PAR and presented in **Section 3.0** were not observed to be present at the time of URS' site visit.

Direction Photo Taken: North			
Description: Apparent nonnative surface material northwest of upper parking lot

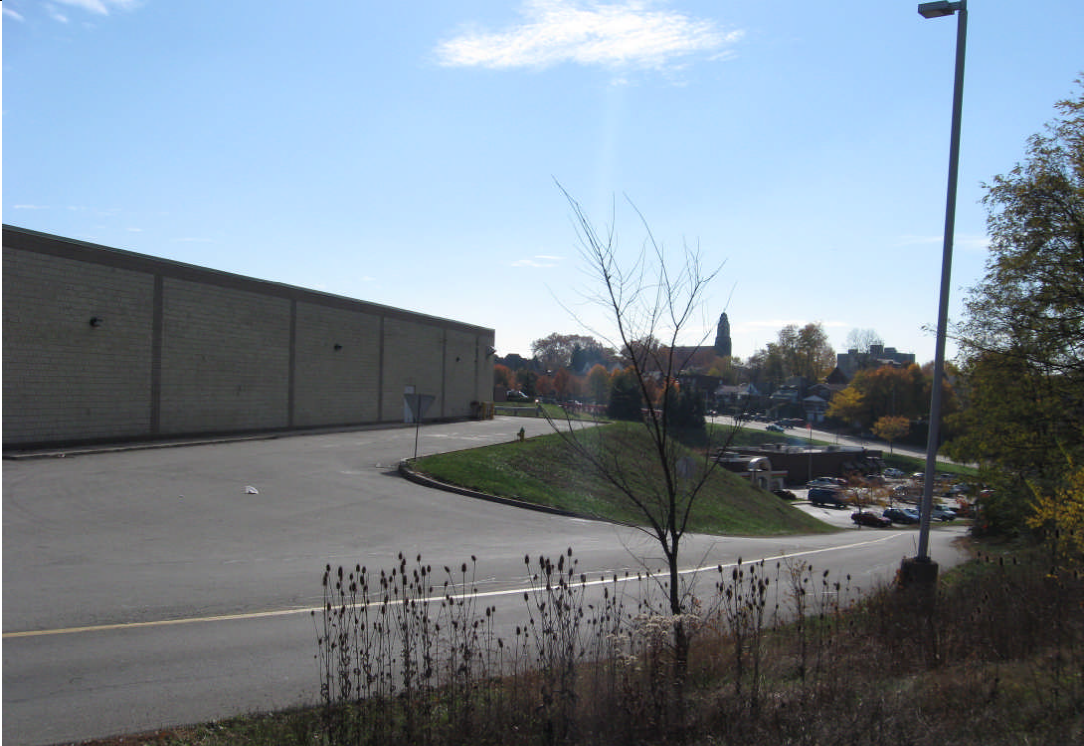
Client Name: Pennsylvania Department of Environmental Protection		Site Location: 1789 Braddock Avenue, Pittsburgh, PA 15218	Project No. 20497896
Photo No. 11	Date: 11/6/08

Direction Photo Taken: West			
Description: Road to lower parking lot and Applebee's.

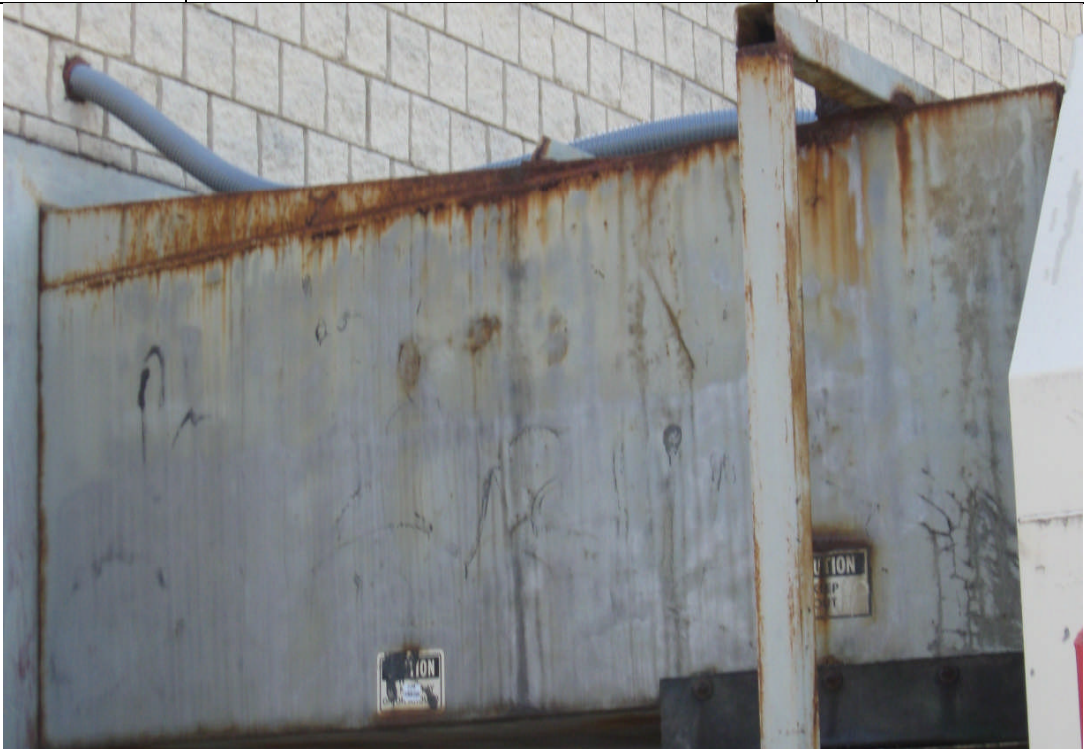
Client Name: Pennsylvania Department of Environmental Protection		Site Location: 1789 Braddock Avenue, Pittsburgh, PA 15218	Project No. 20497896
Photo No. 15	Date: 11/6/08

Direction Photo Taken: East			
Description: Trash compactor located behind mall.

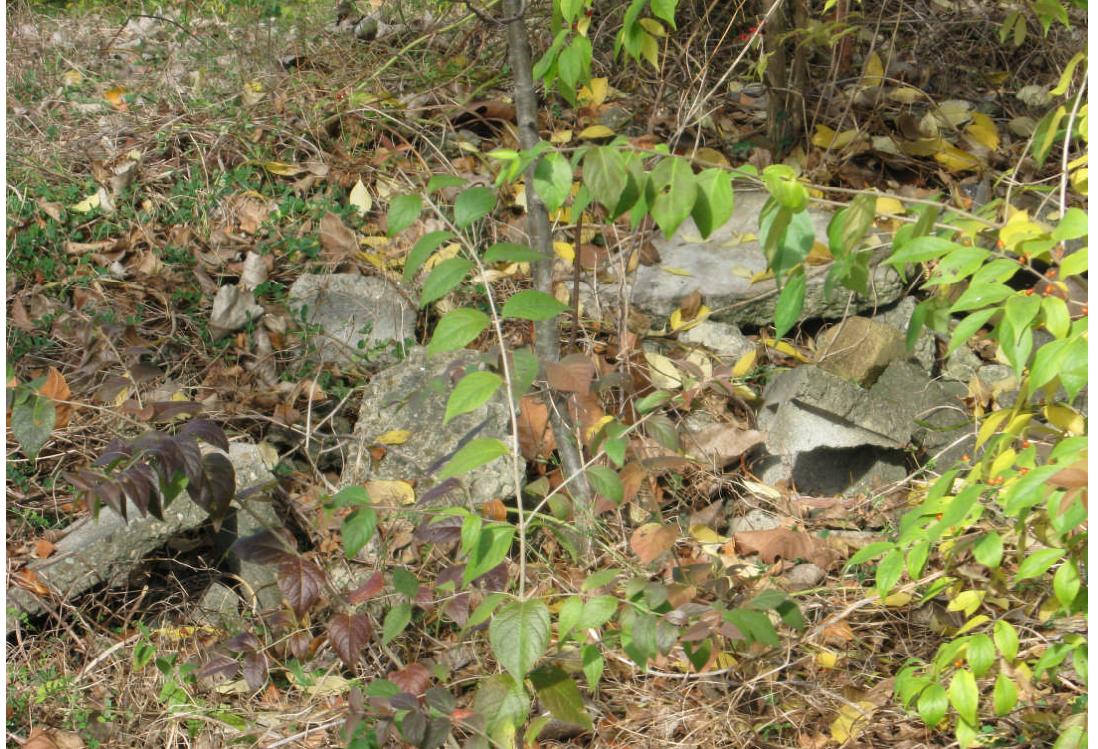
Broken concrete adjacent
to lower parking lot.
